# Hardware Data Sheet Section III Addendum

ET1810 / ET1811 / ET1812 and ET1815 / ET1816

Ether**CAT**<sup>®</sup>   Slave Controller  
IP Core for Intel<sup>®</sup> and Xilinx<sup>®</sup> FPGAs

Version 3.0  
Date: 2019-05-31

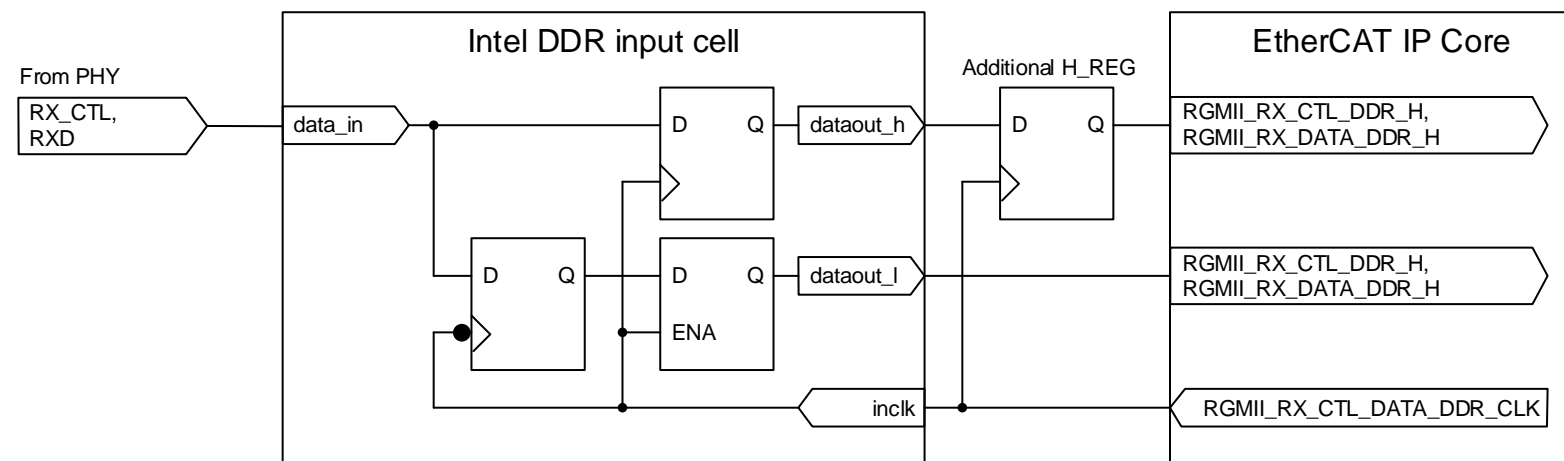
Figure 1: Additional H\_REG for RGMII inputs using Intel DDR input cells

**2.4.1.7 EtherCAT IP Core V3.0.0 – today: DE2-115 NIOS RGMII example design is missing a register for DDR input signals**

The DE2-115 NIOS RGMII example design uses an Intel DDR input cell which uses a reversed DDR\_L/DDR\_H ordering. Due to a certain behaviour of the PHYs on this boards, this will not cause problems, but using the example design for other PHYs can result in receive errors.

An additional register has to be added to the DDR\_H path for each RX\_CTL/RX\_DATA[3:0] signal, according to the following schematic:

Example code for the additional H\_REG for one port (duplicate and update port numbers for additional ports):
