# Hardware Data Sheet Section III Addendum

ET1810 / ET1811 / ET1812 and ET1815 / ET1816

Ether**CAT**<sup>®</sup>   Slave Controller  
IP Core for Intel<sup>®</sup> and Xilinx<sup>®</sup> FPGAs

**Section III – Addendum**  
Design Flow Compatibility, FPGA Device Support, Known issues

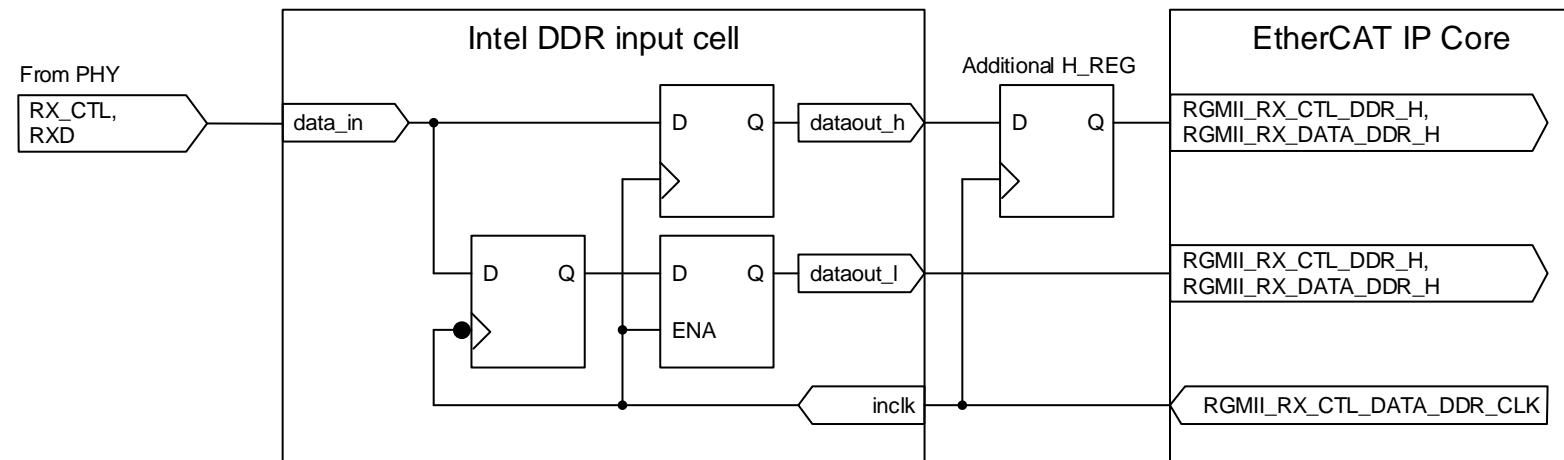
Figure 1: Additional H\_REG for RGMII inputs using Intel DDR input cells

2.4.2.1 EtherCAT IP Core before V3.0.10 Patch 3: DE2-115 NIOS RGMII example design is missing a register for DDR input signals

The DE2-115 NIOS RGMII example design uses an Intel DDR input cell which uses a reversed DDR\_L/DDR\_H ordering. Due to a certain behaviour of the PHYs on this boards, this will not cause problems, but using the example design for other PHYs can result in receive errors.

An additional register has to be added to the DDR\_H path for each RX\_CTL/RX\_DATA[3:0] signal, according to the following schematic:
