Hardware data sheet section III addendum

ET1810 / ET1811 / ET1812 and ET1815 / ET1816

EtherCAT[®] Slave Controller IP Core for Altera[®] and AMD[®] FPGAs

Section III – Addendum
Design flow compatibility, FPGA device support, known issues

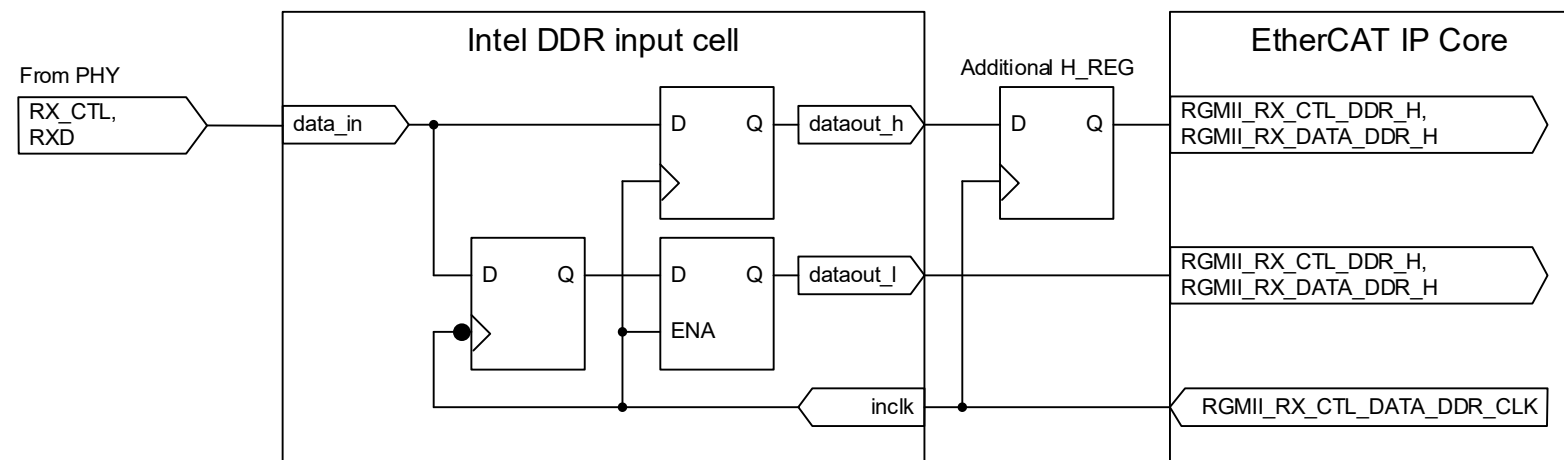
Figure 1: Additional H_REG for RGMII inputs using Altera DDR input cells

2.4.2.1 EtherCAT IP Core before V3.0.10 Patch 3: DE2-115 NIOS RGMII example design is missing a register for DDR input signals

The DE2-115 NIOS RGMII example design uses an Altera DDR input cell which uses a reversed DDR_L/DDR_H ordering. Due to a certain behaviour of the PHYs on this boards, this will not cause problems, but using the example design for other PHYs can result in receive errors.

An additional register has to be added to the DDR_H path for each RX_CTL/RX_DATA[3:0] signal, according to the following schematic:
