# Application Note

## Ether**CAT**<sup>®</sup> Slave Controller Development Products

### Frequently Asked Questions and Troubleshooting

Version 1.1  
Date: 2011-12-15

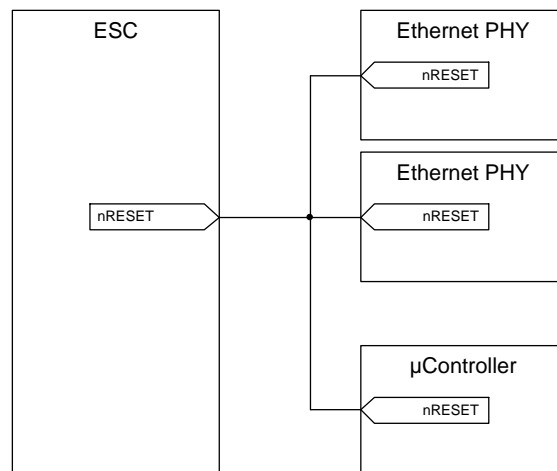
Figure 1: Reset connection principle

A  $\mu$ Controller attached to the PDI should also be reset by the ESC (e.g. by a soft reset via register 0x0040:0x0041).

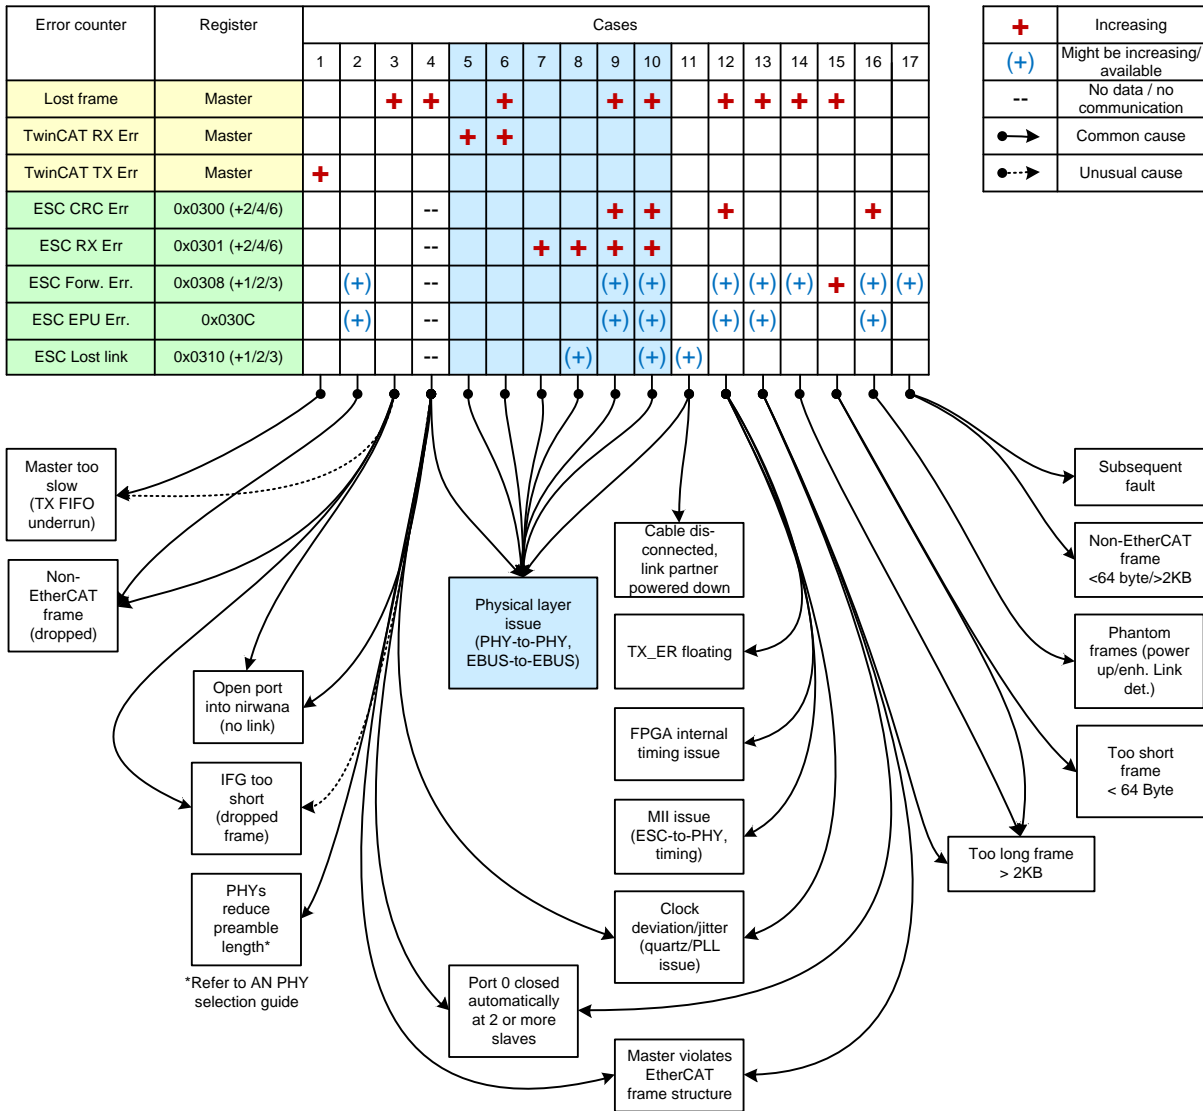
**Figure 2: Error counters interpretation guide**

The following diagram can be used to identify possible error causes. At first, find out which error counters are increasing in your network (or device), and at the master. Compare this with each of the cases shown in the main table of Figure 2 and find the most similar case. Follow the arrows at the bottom of each column to the possible error causes. Use Table 1 for comments and error localization.

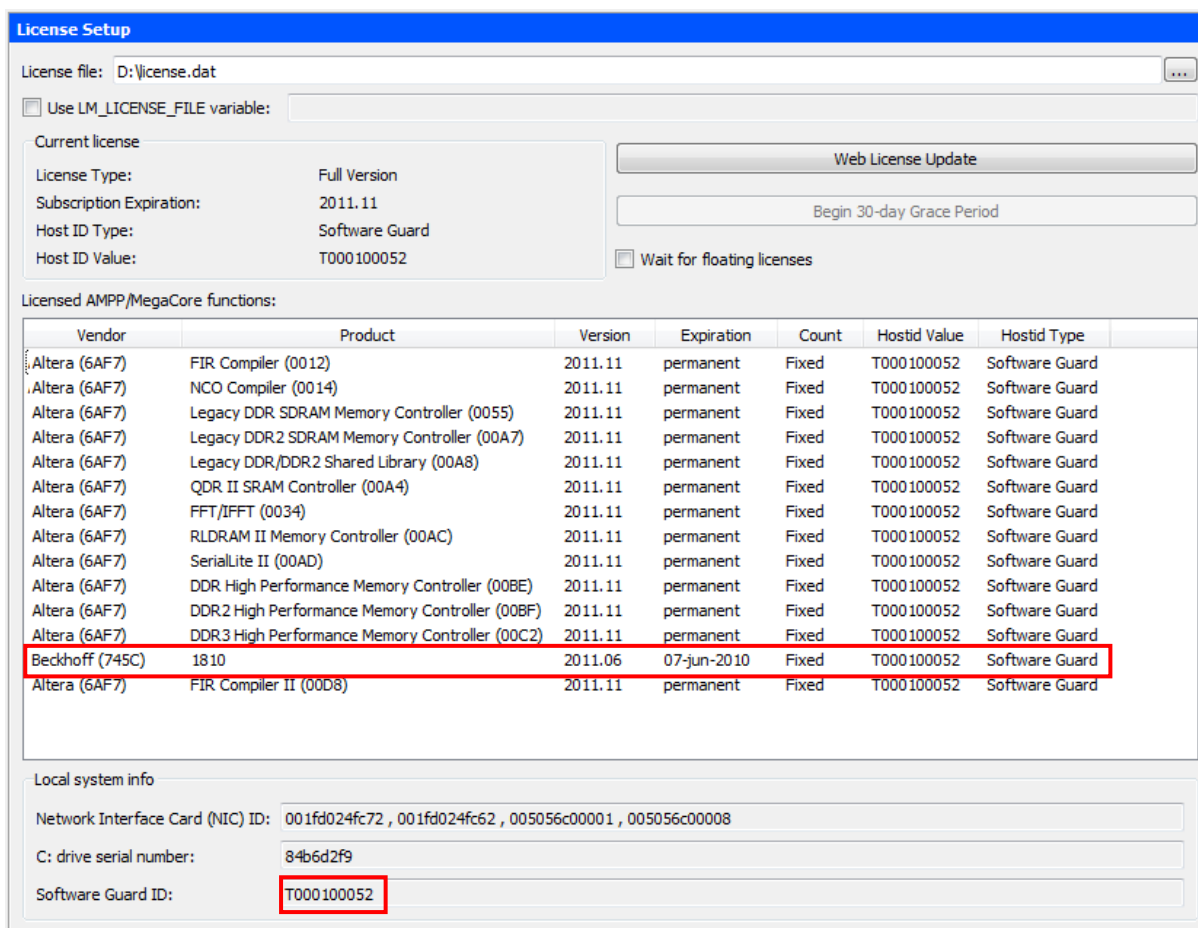
Figure 3: Example license

The EtherCAT IP Core license has Vendor “Beckhoff (745C)”, and Product “1810”. Full license and OpenCore Plus license cannot be distinguished in this window, only during compilation.

1. The version column states the latest release month of an EtherCAT IP Core for which the license is valid. In the example, the license is valid as long as the release month of the IP Core is June 2011 or earlier.
2. The Expiration column shows the date when the license expires. The example license is valid until 2011/06/07. This is the latest date at which you can synthesize the IP Core with this license.
3. The Count column is basically for floating licenses<sup>1</sup> (number of seats). If the value is “Fixed”, you have a node-locked license with one seat.

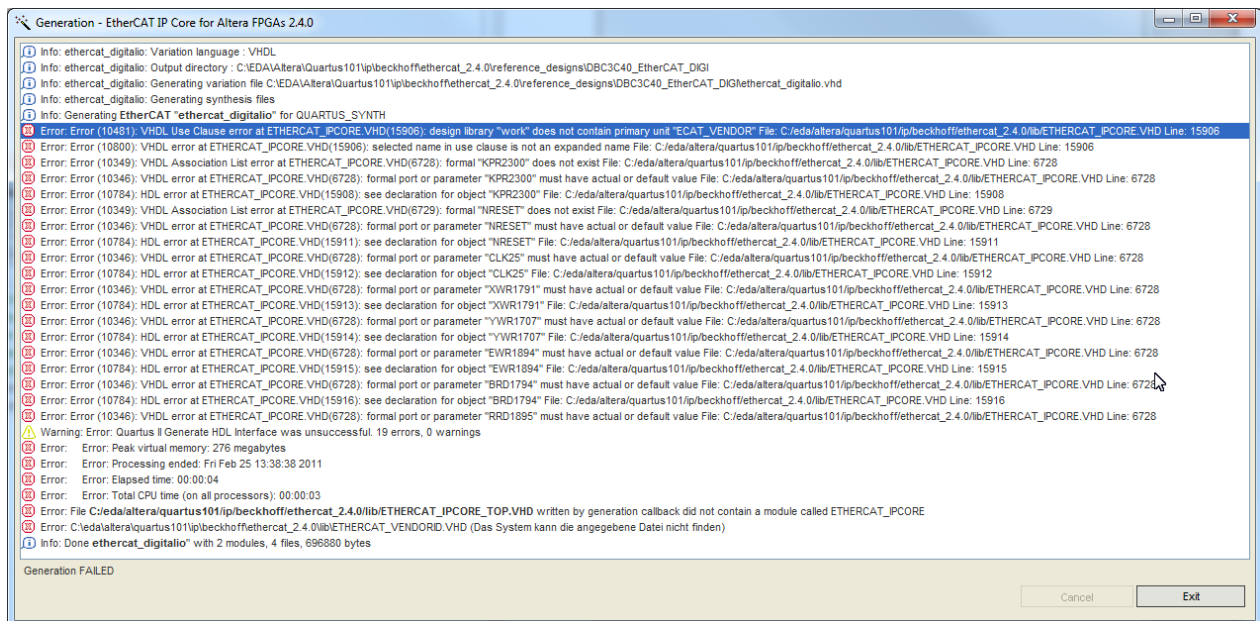
Figure 6: MegaWizard generation issue

Error: Error (10481): VHDL Use Clause error at ETHERCAT\_IPCORE.VHD(15906): design library "work" does not contain primary unit "ECAT\_VENDOR" File: C:/altera/quartus101/ip/beckhoff/ethercat\_2.4.0/lib/ETHERCAT\_IPCORE.VHD Line: 15906

If the vendor ID package is missing in the installation folder (e.g., because it was not installed/found during installation), it has to be added manually to the installation folder. Refer to the EtherCAT IP Core datasheet for instructions. Regenerate the EtherCAT IP Core afterwards.

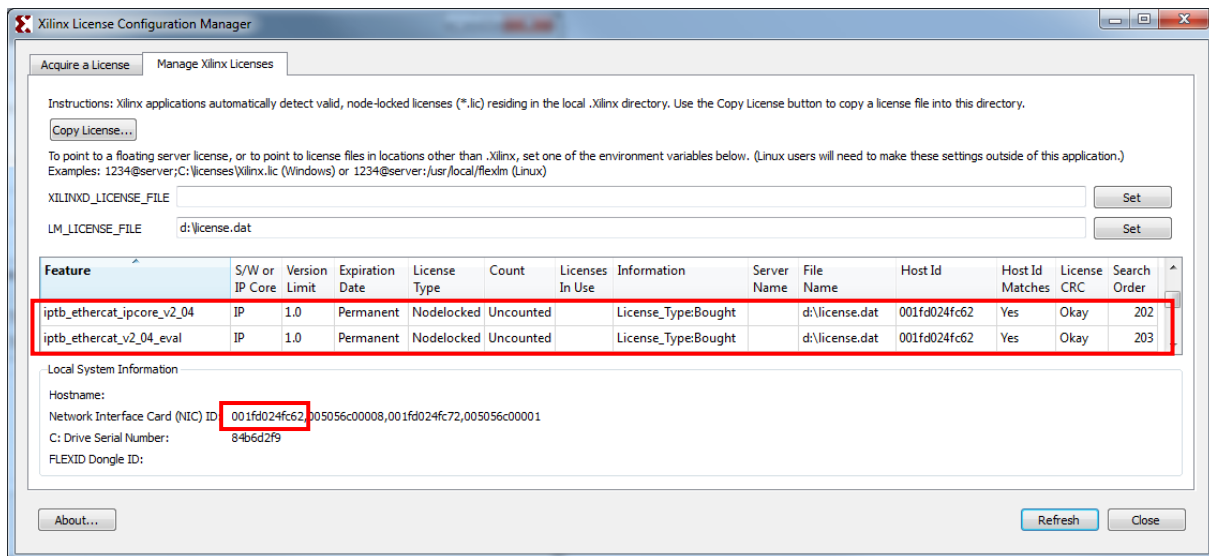
Figure 11: Example license

You can check if your license is valid by invoking Xilinx ISE, menu Help – Manage License...

- The EtherCAT IP Core license has one of the following features:
  - iptb\_ethercat\_ipcore\_v2\_04 for the full version (IP Core Version 2.04a-z)
  - iptb\_ethercat\_v2\_04\_eval for the evaluation version (IP Core Version 2.04a-z)

- The column “Host Id Matches” says “Yes” if the MAC ID was found, otherwise the value is “No”.
- The “License CRC” column shows the result of the license check

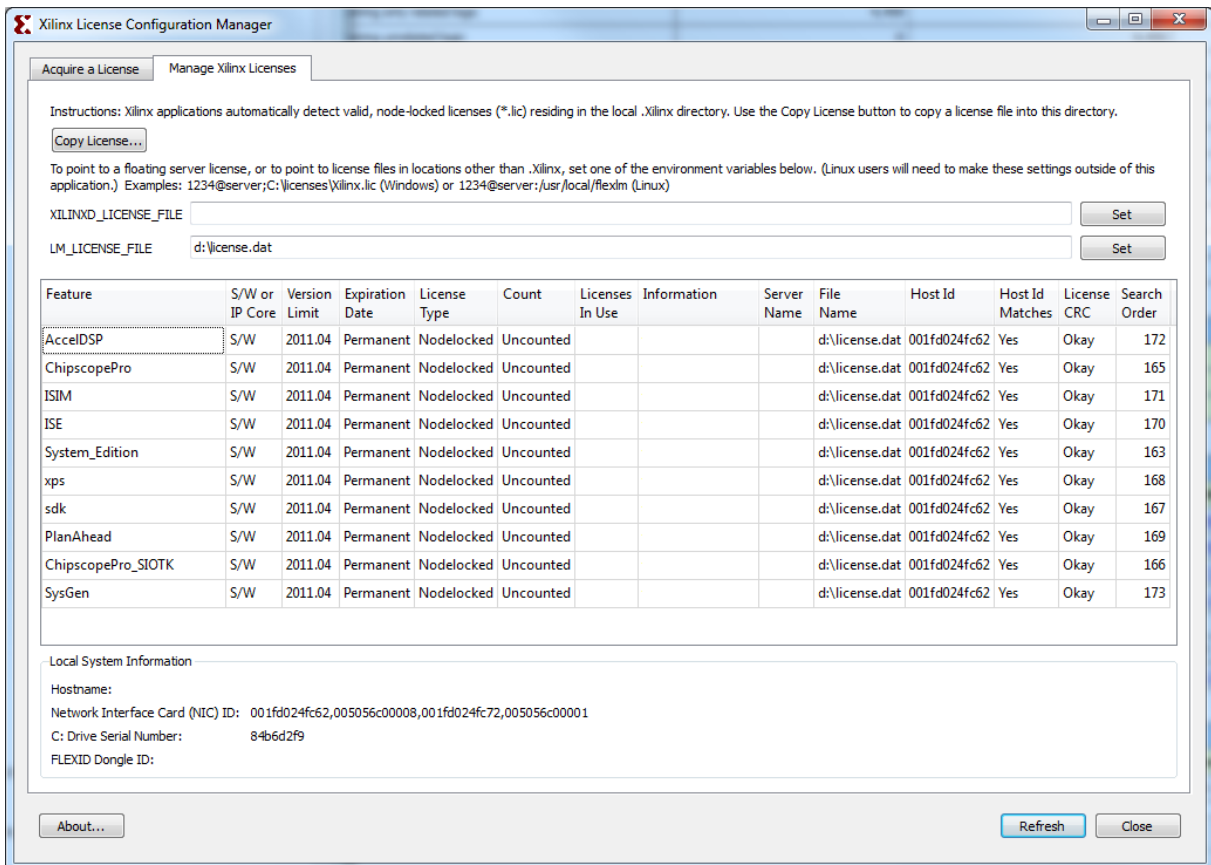
Figure 12: License Configuration Manager: No license available (expecting *iptb\_ethercat\_...*)

This error occurs if either no valid license was found, or if the type of the license file (full, evaluation) is not the same as the EtherCAT IP Core. The error message shows which license is required by the IP Core (highlighted).

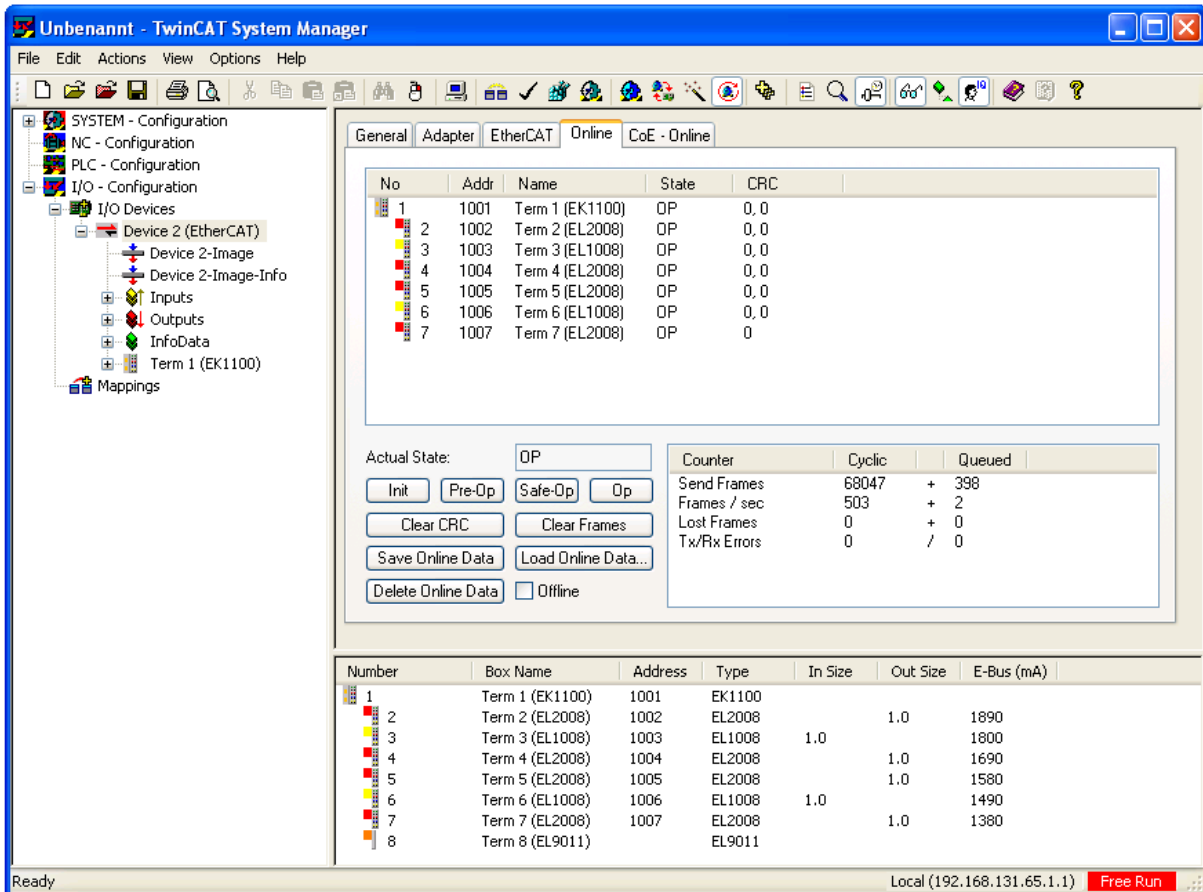
Figure 13: TwinCAT logging CRC error counters

By default, TwinCAT reads out the ESC error counter registers 0x0300/0x0302/0x0304/0x0306 (CRC error port 0-3) and clears them. The results are accumulated in software and displayed in the CRC column for each port of the ESC (separated by commas).

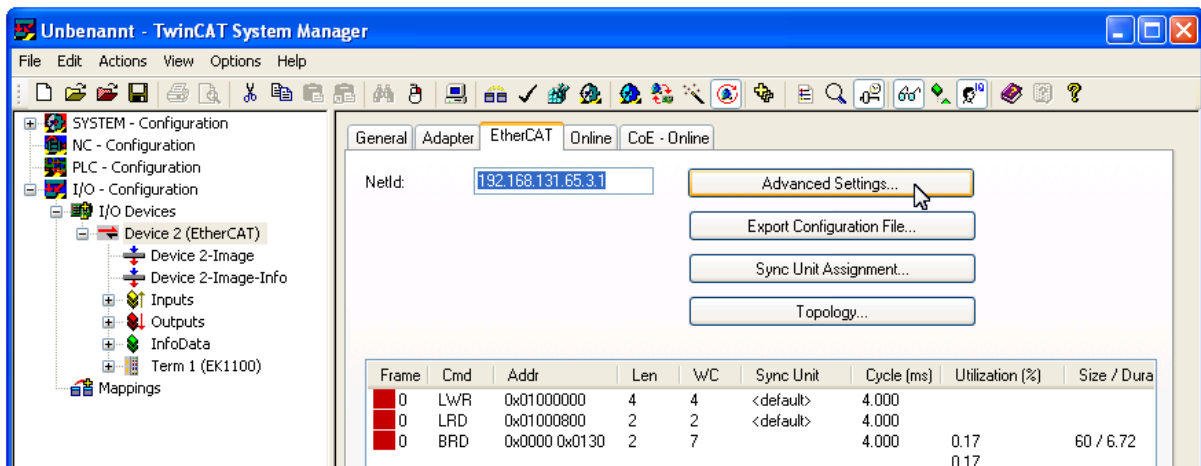
Figure 14: Go to EtherCAT Advanced Settings

1. Go to the “EtherCAT” tab and open “Advanced Settings...”:

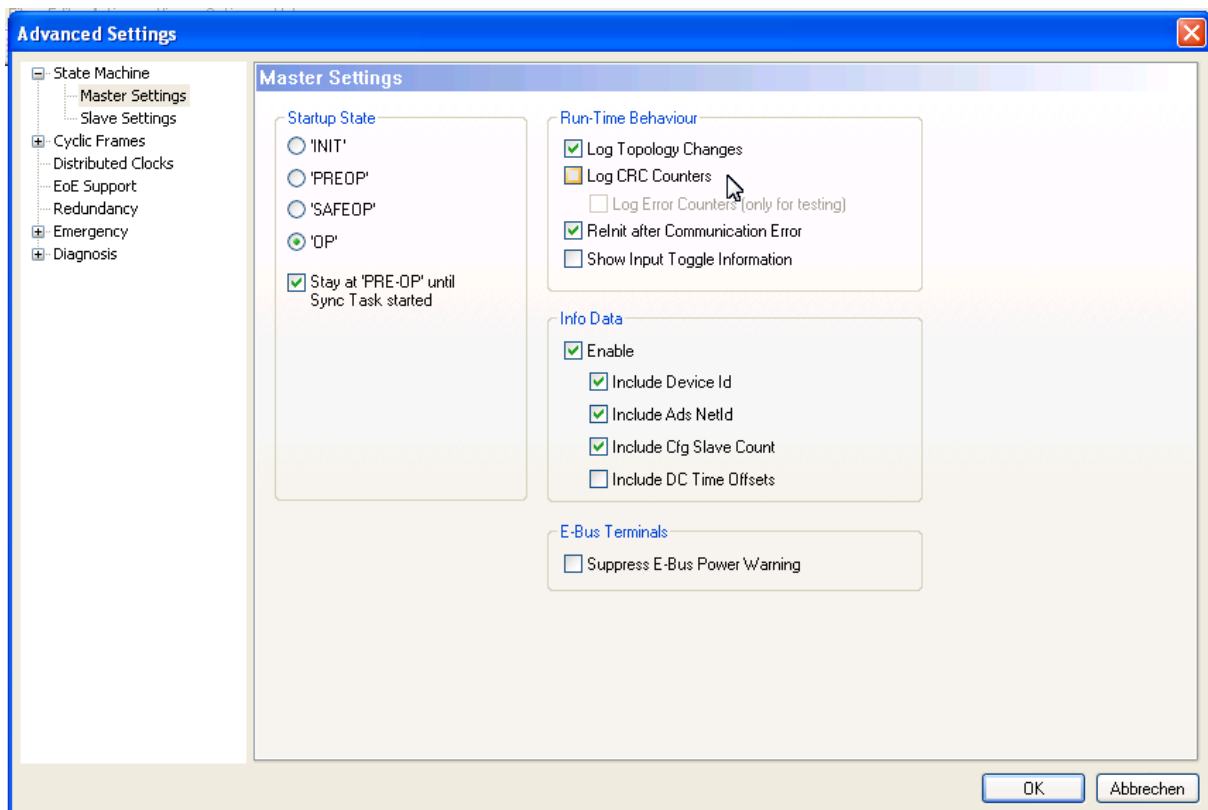
Figure 15: Unselect CRC Counter logging

2. Unselect “Log CRC Counters” and press OK.

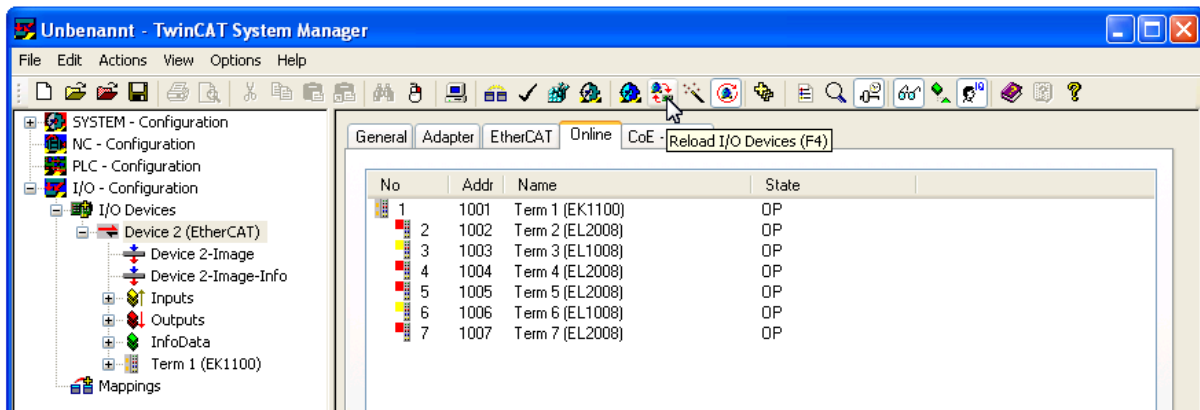
Figure 16: Reload I/O Devices (F4) after disabling CRC logging

**It is very important to reload I/O devices (F4) after disabling “Log CRC Counters”, otherwise the error counters will still be cleared automatically by TwinCAT.**

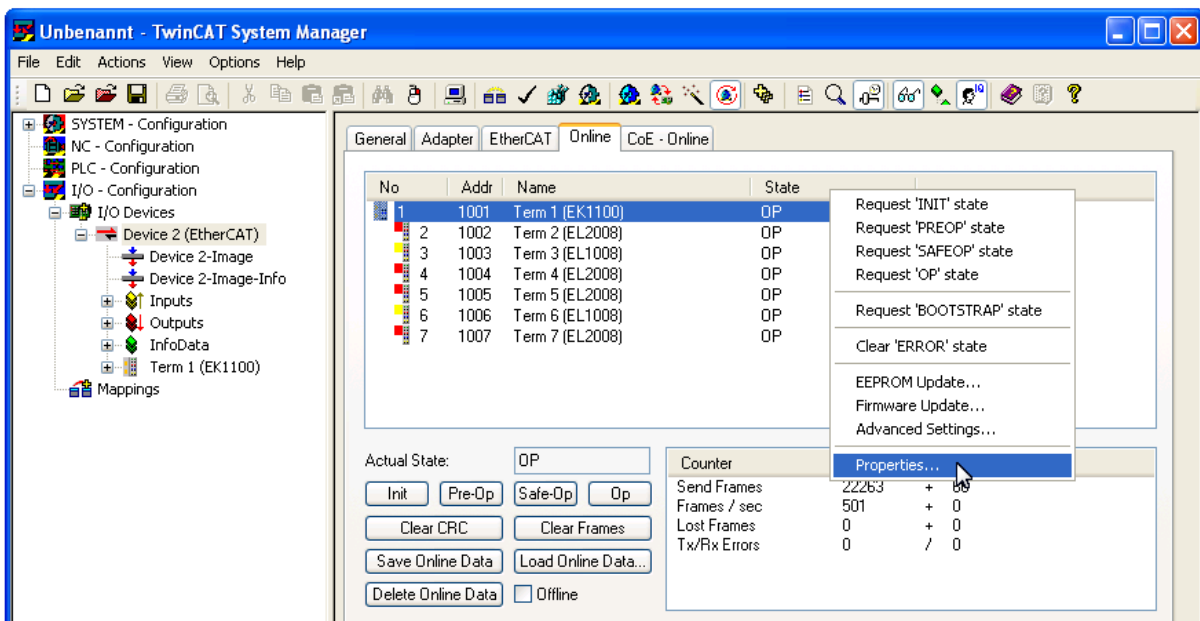
Figure 17: Online view properties

- Now you can add the error counters to the online view. Right-click into the Online view area and select “Properties...”

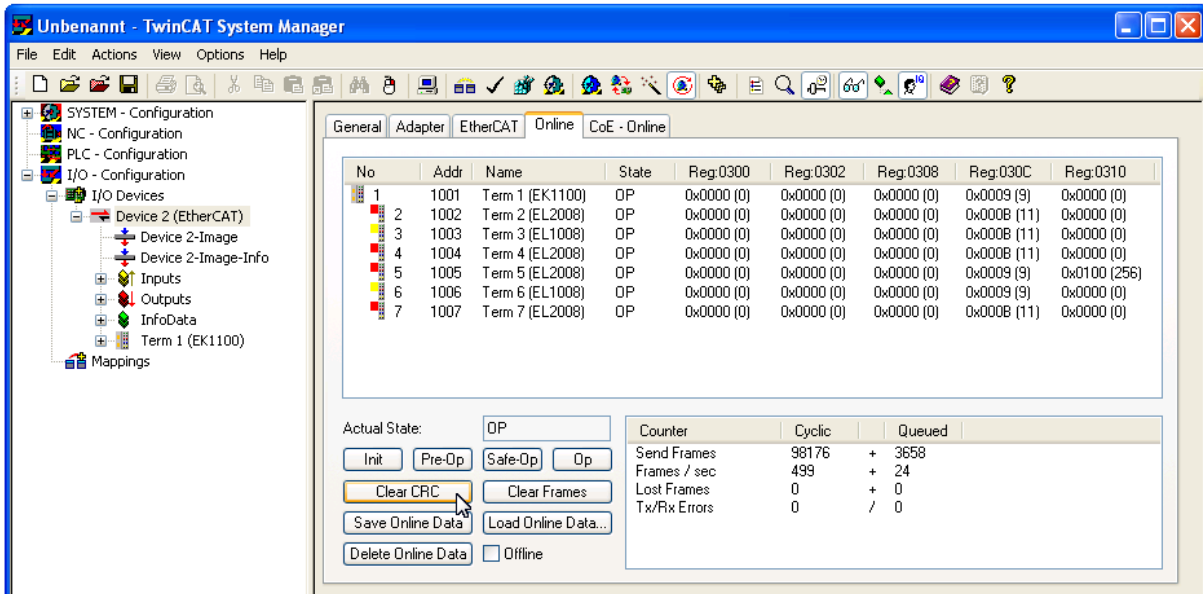
Figure 19: Some power-up errors without significance

- Now you might see some errors in registers 0x030C-0x0313 resulting from power-up. These errors have no significance, only errors increasing during operation are important. TwinCAT reads out and clears only the error counters in register 0x0300-0x0307, and pressing the button “Clear CRC” also clears only these counters. The other counters are still accumulating from power-up until now. Please note that the error counters are shown as 16 bit values, i.e., the column called “Reg. 0300” shows in fact registers 0x0300 (lower 8 bit, right side) and 0x0301 (higher 8 bit, left side).

Press the buttons “Clear CRC” and “Clear Frames” to clear the TwinCAT counters in the lower right area (Lost frames, Tx/Rx Errors).

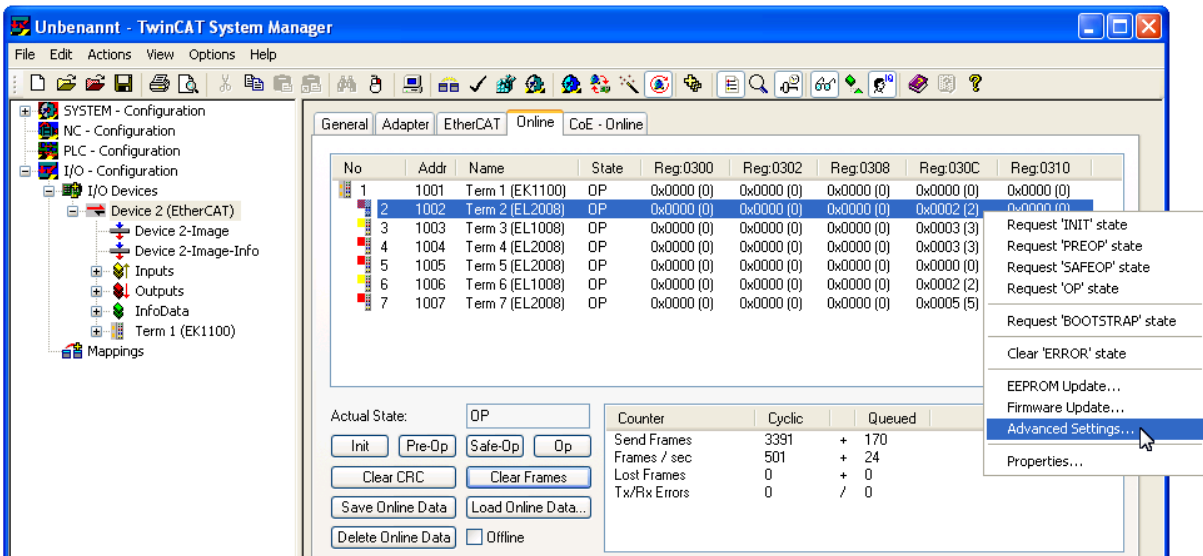
Figure 20: Clear error counters manually in the advanced settings

- If you want to clear all the error counters, follow these steps for each ESC. At first, highlight the ESC with the error counters you want to clear. Right-click into the row and select “Advanced Settings...” from the context menu.

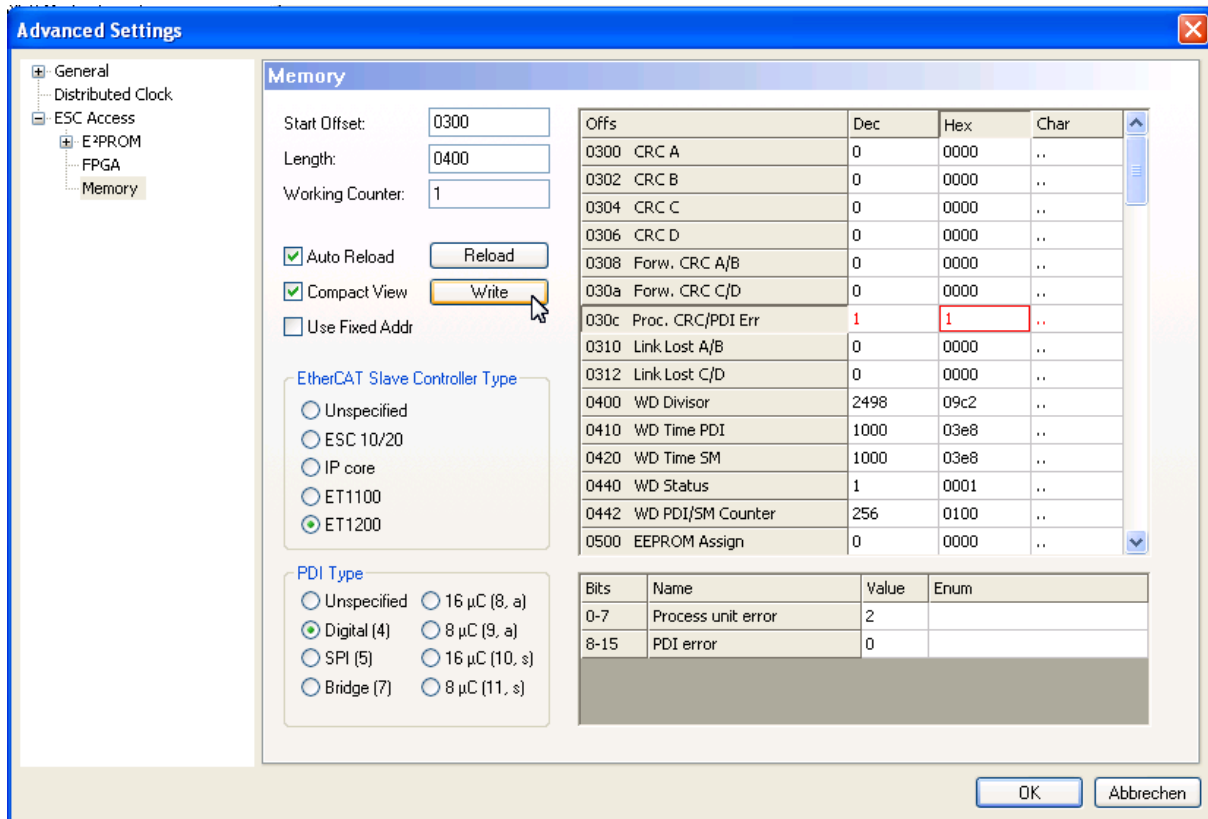
Figure 23: Write to the error counter to clear it

10. Press the “Write” button to write the new value, which in fact clears the error counter.
